Shoreline Survey Report and Action Plan Mumford River - May 2006 Blackstone River Watershed Association

Mumford River Stream Team Report

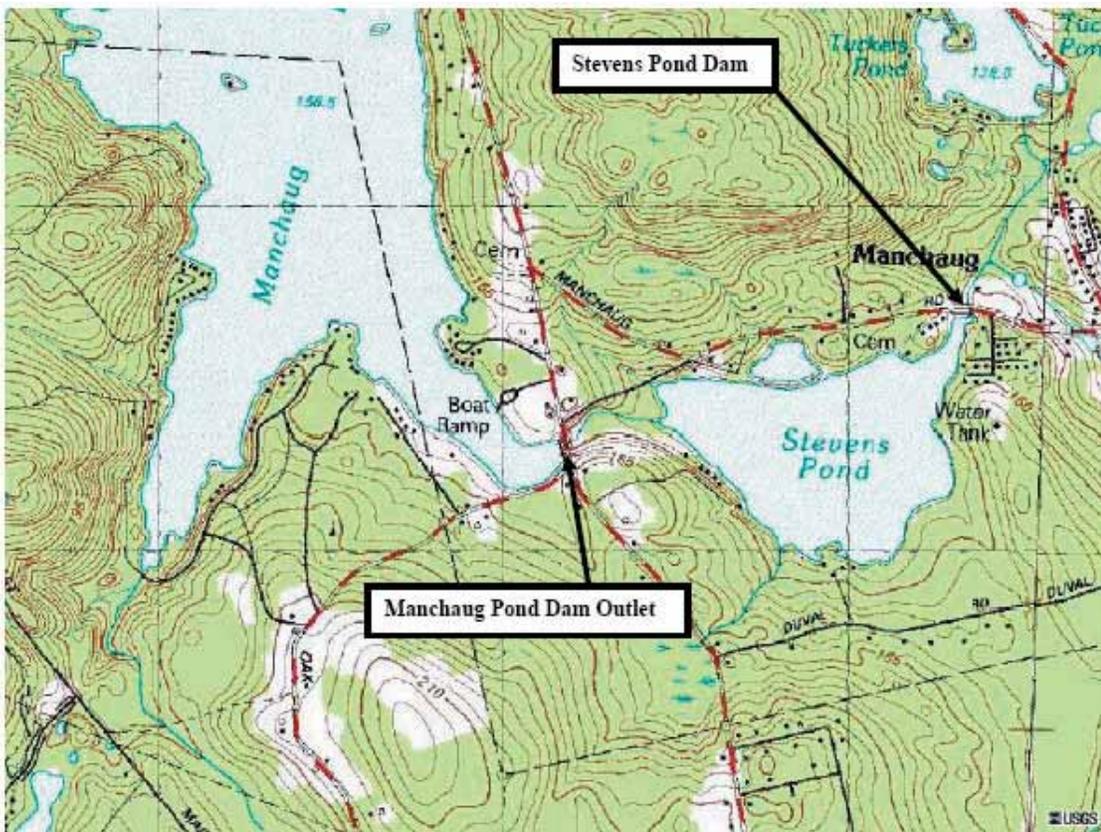
Figure 2. Section 1 - Manchaug Pond Dam Outlet - Stevens Pond Dam
Surveyor: Barbara and Jennifer Lonergan

Having camped in this area over the past 30 years, I have seen this area change from a very pristine area to a congested, overpopulated and over used area. The water used to be crystal clear with lots of fish. Now, it has more campsites on its banks and at least four times as many motor boats. The swimming areas are congested with boat ramps and you can see the gasoline swirling in the water. As the water leaves the dam towards Stevens Pond, it is primarily wooded wetlands with steep banks. It looked like it has a sand bar that stretched 100 feet or more with 6 inches of water. There were tires and other trash in the water and it smelled of dead fish. There was no evidence of fish, insects or birds near the waters edge (Figure 2).

- Trash removal at the mouth of the Mumford River, foaming strong smell, brown with lots of weeds
- Gasoline in the water from recreational boating. Discuss with campground owners. Provide literature to campground.
- Stevens Pond – trash removal and strong smell of dead fish, low water levels

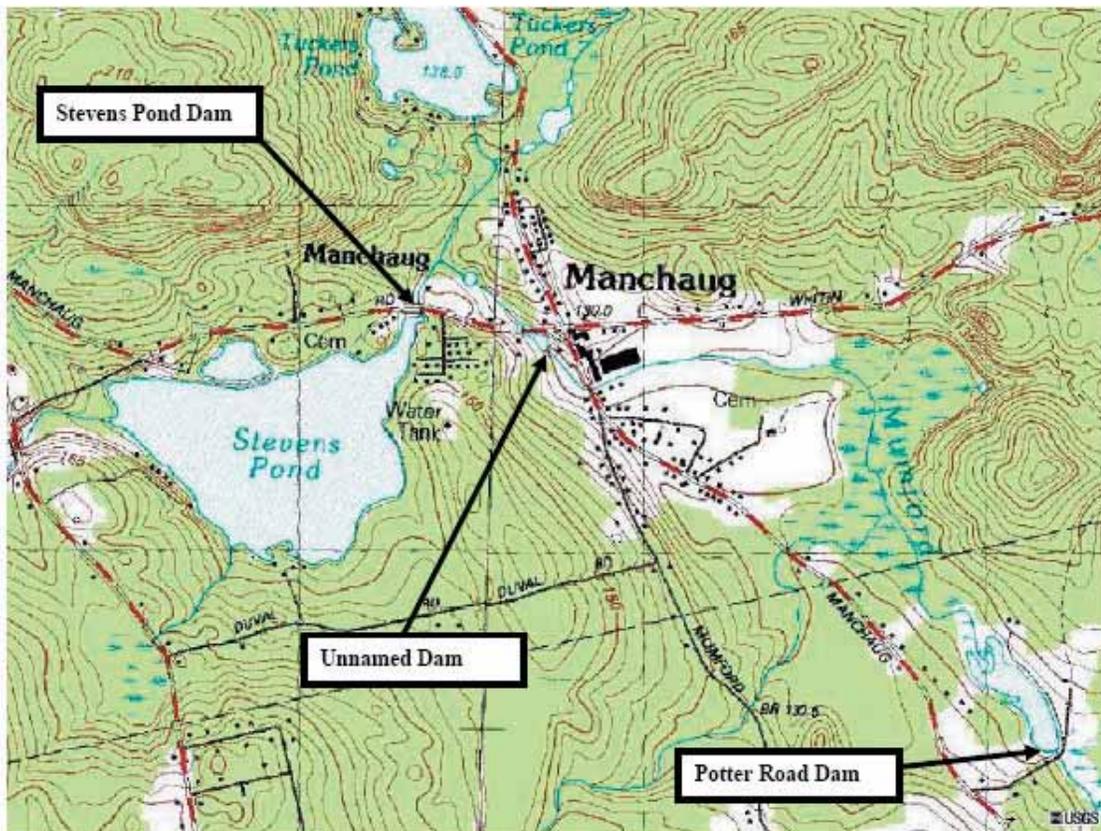
Figure 3. Section 2 - Stevens Pond Dam End - Unnamed Dam in Douglas
Surveyor: Dan, Shelley, Mitchel and Robbie McGonagle

The river was flowing rapidly due to the recent rainfall. This probably accounted for the rapid rising water levels and rapid flow. Lots of organic debris on the bottom of the river. Looking at the bank there were several trees, shrubs and exposed roots. Not a lot of evidence of wildlife except for a dead bird. Evidence of construction in residential area (Figure 3).

- Clean up construction bails
- Alert neighbors of run off from private property into river
- River debris clean up

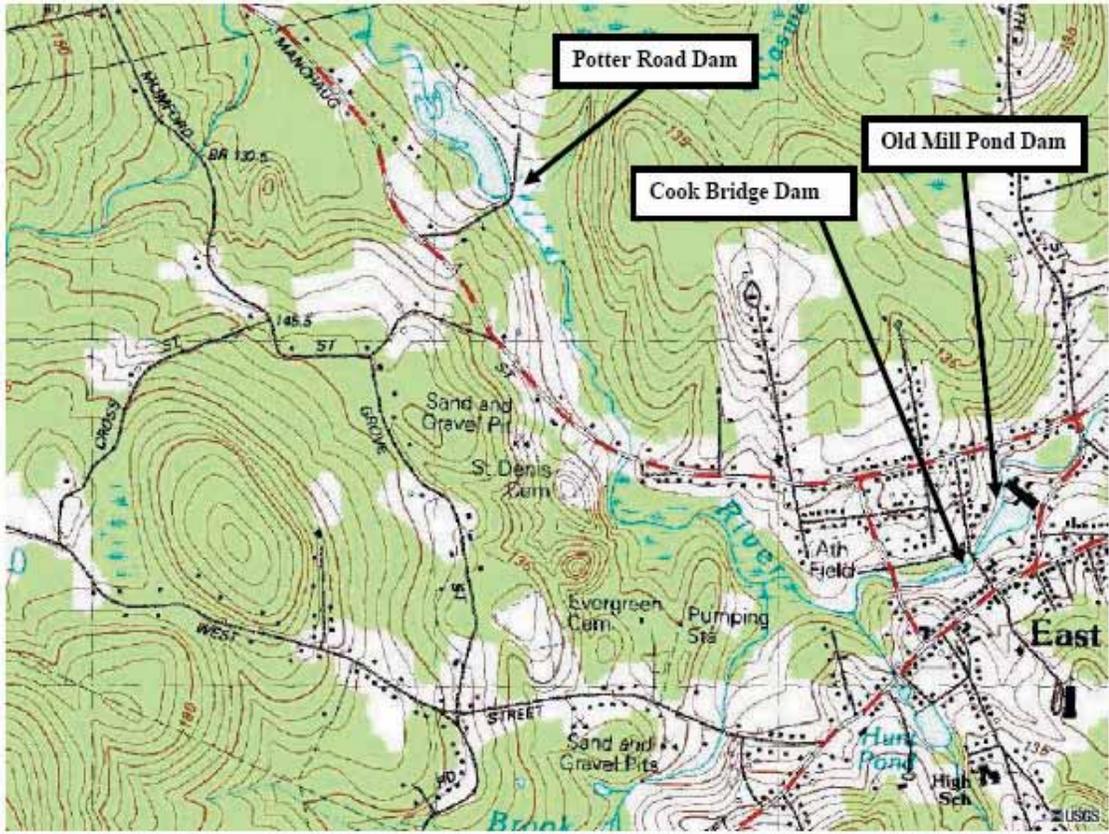
Figure 4. Section 3 - Soldiers Field Douglas - Gilboa Street Dam
 Surveyor: Sam and Douglas Bowen

Behind the Douglas treatment plant, a machine dug channel from the plant down to the river. Sewage was ripe and gathered in a large area on top of the water. Several natural tree obstructions, however, the water was able to continue its flow. Smell was repulsive at the sewage dumping area. There appeared to be a thick coating on the water. The river is quite marshy at the DEP site, however it widens dramatically as it flows to the pond in front of Gilboa Street Dam. Old rusty pipes coming over the banks of the river from the apartment side. Construction looks completed but large beams have not been removed (Figure 4 and 5).

- Clean up sewage behind Douglas treatment plant- smells very bad and discoloration of water/thick coating atop of water**
- Cook Street Bridge – oil clean up**
- Old Mill Dam – Old rusty pipes coming into the river from apartment buildings with hay barrier left behind from construction**

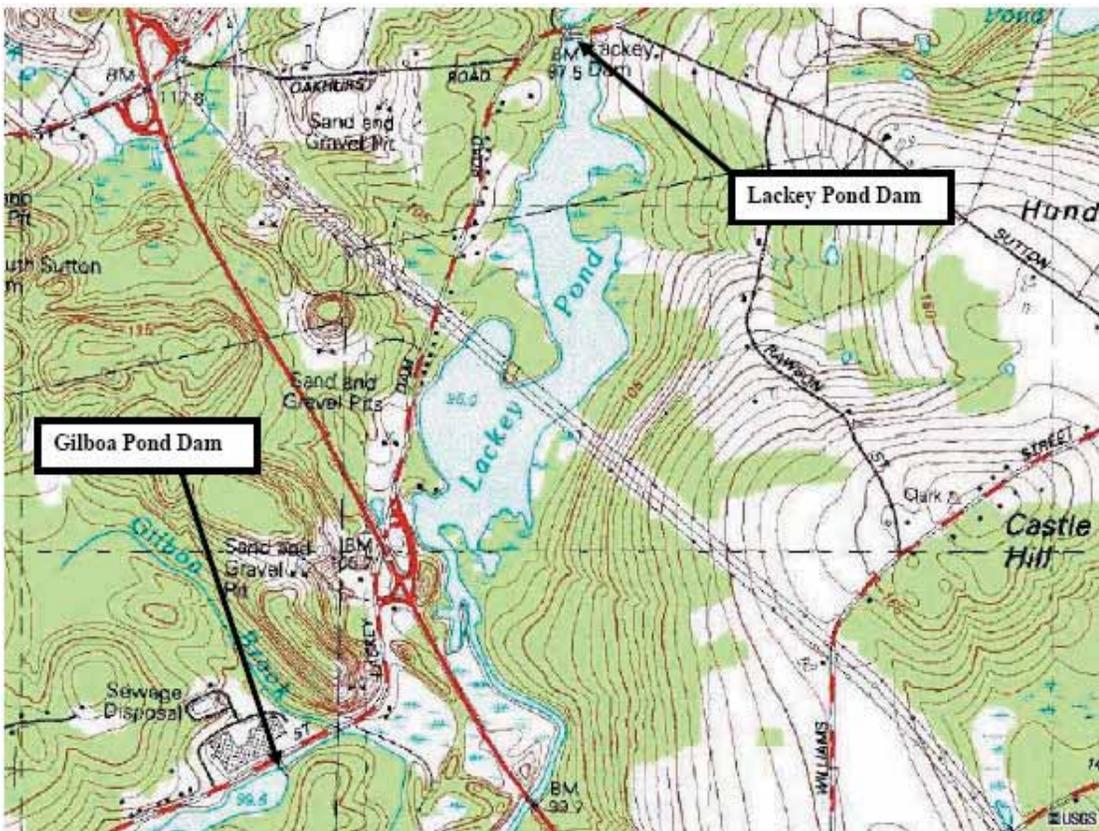
Figure 6. Section 4 - Gilboa Street Dam - Lackey Dam
Surveyors: Cal Kooistra

Segment begins at Gilboa Dam in Douglas, MA. Evidence of silt, sand and gravel. Water odor was musky and tea colored. Water level seemed low for this time of year and there were lots of Pickerelweed, Milfoil, White Water Lily and Hydrilla. The area down river contained many trees, shrubs and marshy wetlands. Several drainage pipes along this segment all appeared to have no flow. Along the river there was a gravel pit and a house that had lots of trash (bulldozer) / junkyard on the bank of the river (Figure 6).

(Same segment by canoe – Hirsch) The cove was fairly free of garbage. Residential houses have access to water. Water running but not very swiftly. Clean smell with no apparent odor. Water in midsection was deeper than canoe paddle. Cove filled with vegetation but shallow along shoreline. Downed natural debris and lots of fish and other wildlife. Considerable amounts of trash crossing the highway at 146 (Figure 6).

- Trash removal from route 146 by Gilboa Dam
- Removal of large floating items (tires, propane tanks) in cove

- **Trash pick up near 146**
- **Check water levels in the future near shallow marshy areas**

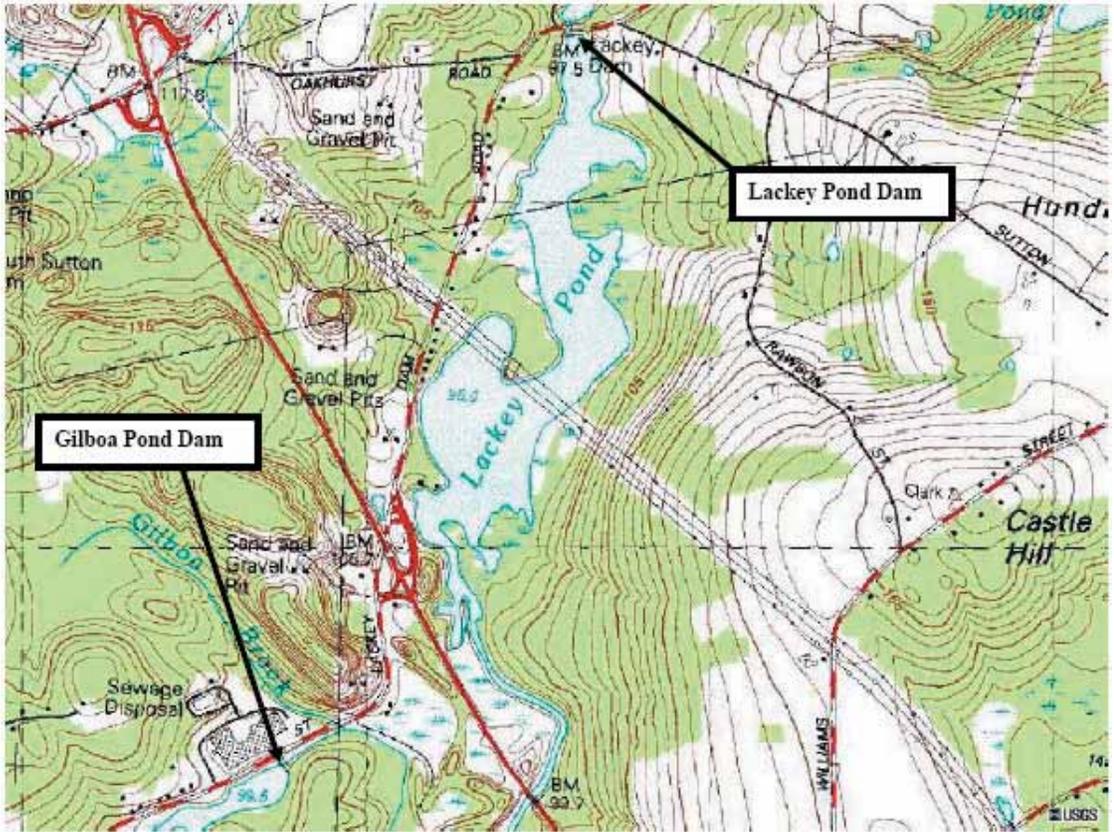
Figure 7. Section 6 - 560 Douglas Road to Unnamed Dam Bridge
 Surveyor: Bob and Joanne St. Germain

Along the waters edge at a residential site there are several piles of grass clippings to keep vegetation from regrowth. Water is full of what appears to be algae (Figure 7 and Figure 8).

- **Neighbor is dumping grass clippings into the water and needs to be informed about dumping**
- **Trash removal along river**
- **Lily pads and other plants are taking over waterway**

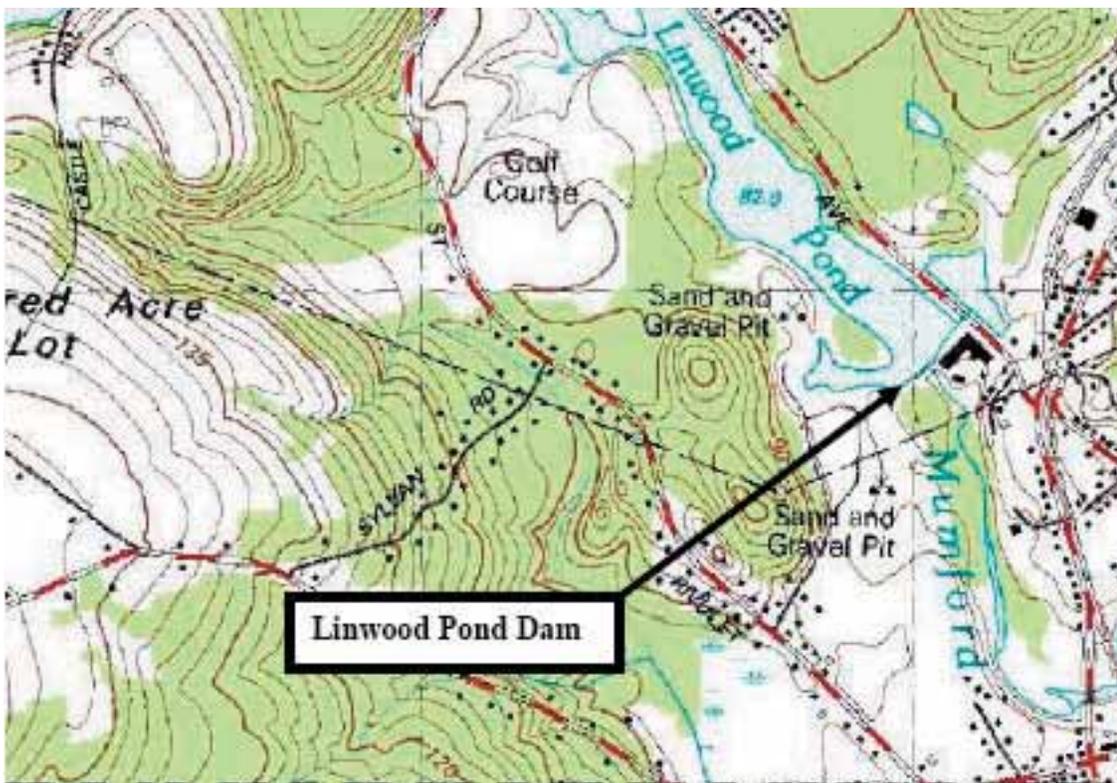
Figure 9. Section 7 - Wild Bird Gardens - Both sides of the River
Surveyor: Erin Andersen, Nancy DeMers, Olivia - Glenn and Evan Herbert,
Beth and Paul Milke, Harold and Nancy Perkson and Alex Thompson

Linwood Pond (Figure 9) was surveyed by two teams. The left bank (heading downstream) runs along Linwood Avenue. It contains the Mumford River Walk, a wooded path. The River along this area has received the attention of a group of Northbridge High School Students concerned about the environment.

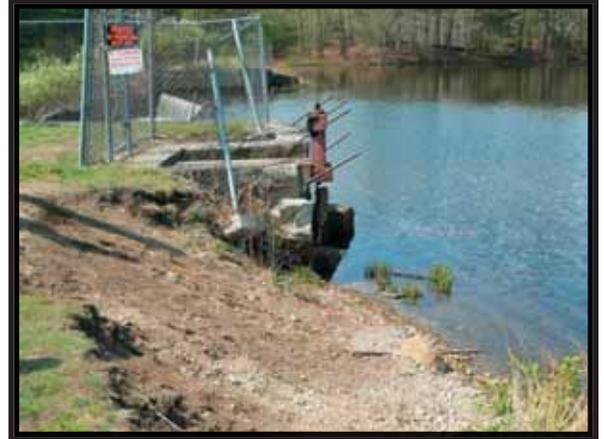
Erosion on river bank behind the Gold Course in Linwood, MA.

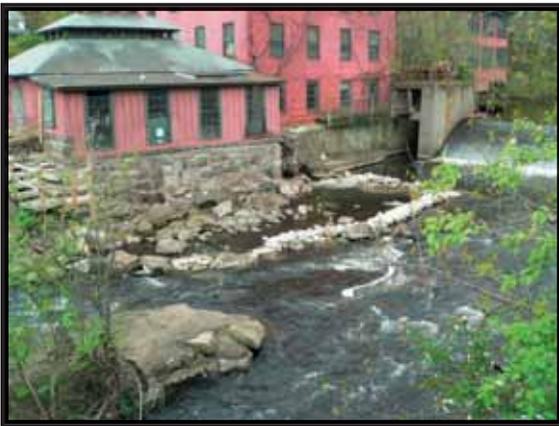
There appeared to be a significant runoff problem from the roads above the river, and many rocks and sandbags had been placed along the side of the building, down the embankment, and in the river. This is a site of ongoing construction (as of September 2006) and will need to be rechecked in the future.

Sand bags at construction at the mill in downtown Whitinsville, MA.

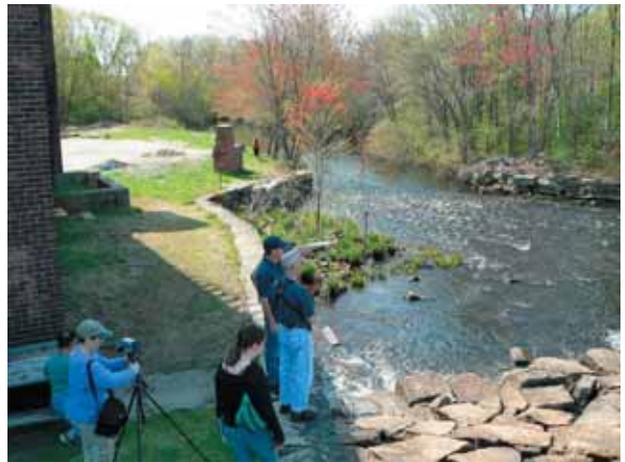
This is an area of significant concern, mainly because of eroded spaces on the earthen dam itself. One of the most heavily eroded spots is at the spillway, which is fenced off and is posted “No Trespassing.” Jeff Hickson, who operates Wildbird Gardens in the Linwood Mill, has expressed his concern about the erosion to several survey team members. He described the problems he has had with people who fish from the dam and ignore the signs.

Linwood Dam baniking, Linwood, MA

If a solution to this erosion problem is a public canoe launch/fishing platform, a discussion might begin on the most suitable location for one, possibly another spot that might handle more foot traffic than the dam.

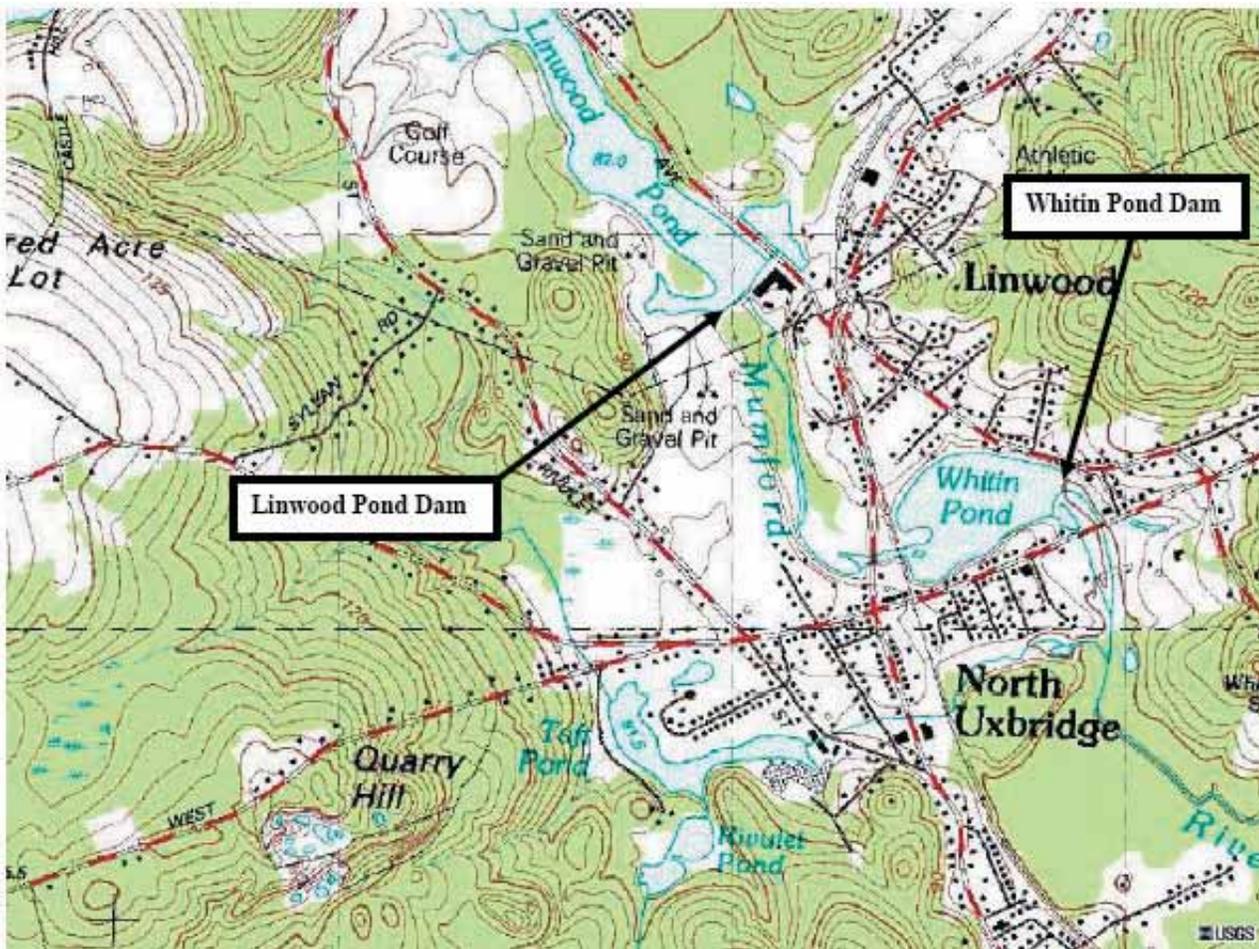
Figure 11. Section 8 - Linwood Dam - Progressive Club - Linwood, MA
Surveyor: Michael Pouliot

From the upper dam the river runs for a couple hundred yards where it is joined by a canal from the old mill. The canal is full of debris and it is orange colored. The river runs several hundred more yards to the pond area. West bank of pond is a large wetland. The East bank rises. The river runs under Route 122 and Railroad Bridge and emerges into lower Whitin Pond. Much of the shoreline on Whitin Pond is surrounded by granite blocks. Some of the East bank has eroded and much of the shoreline is covered in trash. At the upstream end of Whitin Pond is a pair of nesting swans. The upstream west of the pond has wetlands. At the bottom end of the pond is a very lovely little public area that bordered the dam on the East bank.

- **Removal of trash/debris**
- **Erosion in the West Bank on Hartford Avenue side**
- **Water needs to be assessed because of the orange coloration (possible leach field)**

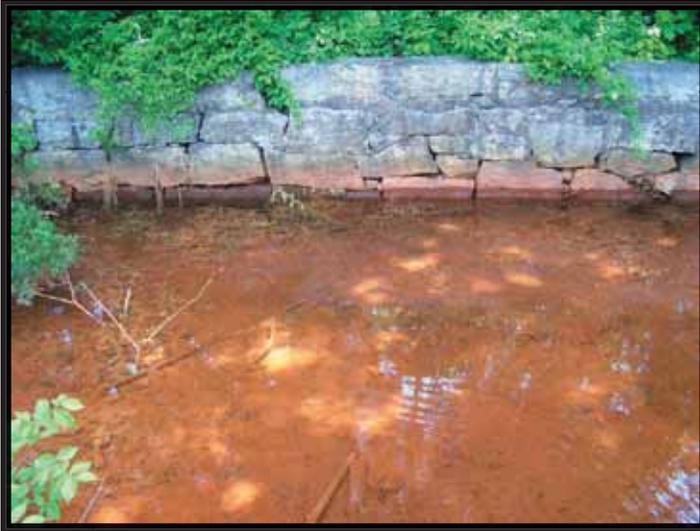
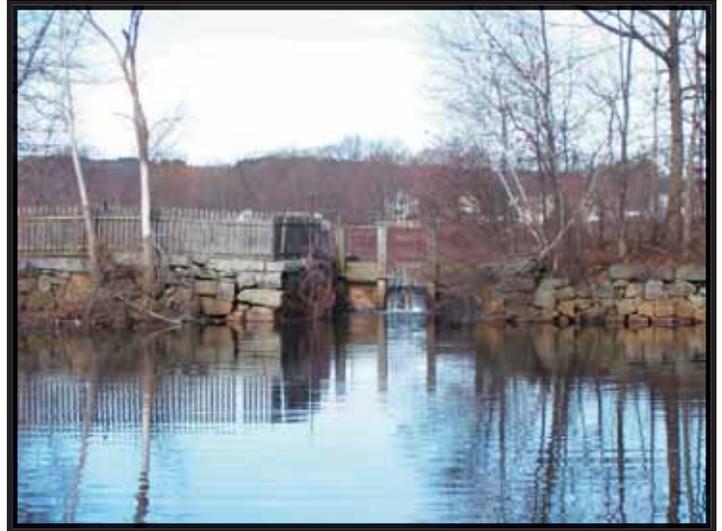
Section 8. images indicate coloration of the river bottom and structure of dam
Surveyor: Michael Pouliot

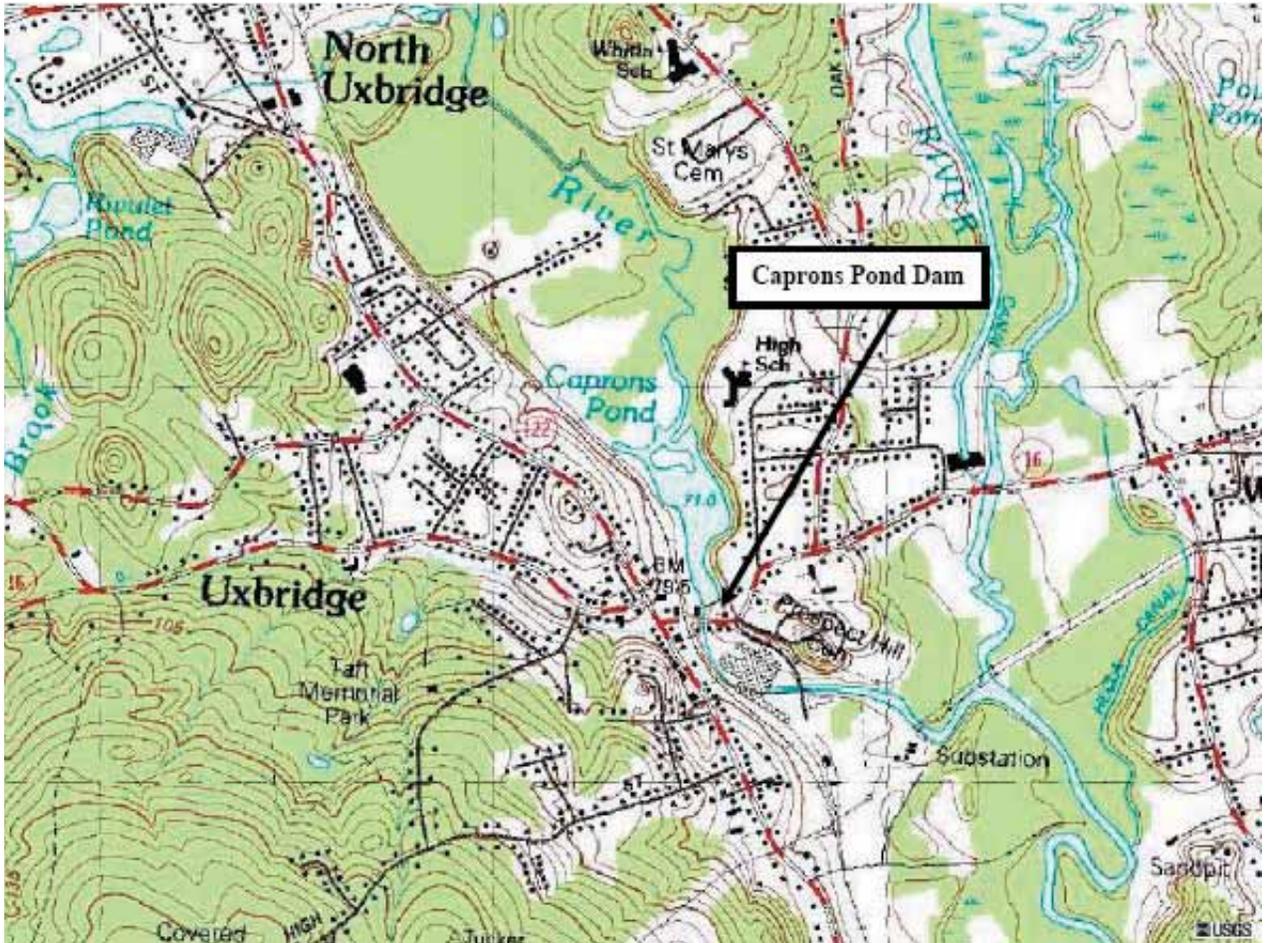
Figure 12. Section 9 - Hartford Street/Route 16 - Capron Park Mill Dam
Surveyor: Maggie and Jim Plasse

Started survey at Capon Park Mill pond and dam at strip mall on Route 16 in Uxbridge (N 42.07722, W 71.62867). Informal canoe launch on walking path behind parking area (N 42.07742, W 71.62888). Walked path on west bank of river. Wooded and wetlands between railroad bed provide protection to the river in this section. East bank of river appeared to be protected by natural vegetation also. Some trash found along pathway. Appears to be teen party destination. River vegetation includes arrowheads and feathered plants. Abandoned oil tank found. No oil in it. Been there a while. Dry well from storm drain. No pipe visible. Open area with kid's toy car. Trail turns to marshy wetlands. Had to continue walk on rail bed (N 42.08196 W 71.60100). Followed Homewood Street back to river from rail bed. River protected by wetlands and wooded areas up to mill on Hartford Street. Not passable on foot up stream between Homewood street. At Hartford St. a resident said that river is navigable between Hartford St. and Route 16. Would have been better to survey this section by boat. (N 42.08500, W 71.60176).

- Phragmites removal
- Senior housing to the park – organize clean-up
- Canoe launch / public access: Contact Department of Conservation and Recreation and Lynch's Liquor Store
