Blackstone River Watershed Association

Peters River Project Stream Survey

Summary Report

Project Coordinator: Michael Sperry
4/15/2015

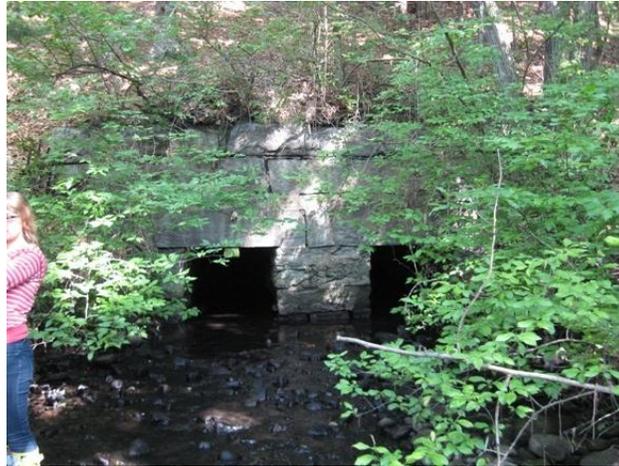
The SNETT is an abandoned railbed that once supported passenger service from Boston to New York. The section that passes through the Peter’s River subwatershed was built in 1849. The Peters River culvert is constructed of stone and granite block. Crayfish and deer tracks were observed at this crossing.

Figure 2 Culvert under the Southern New England Trunk Trail.

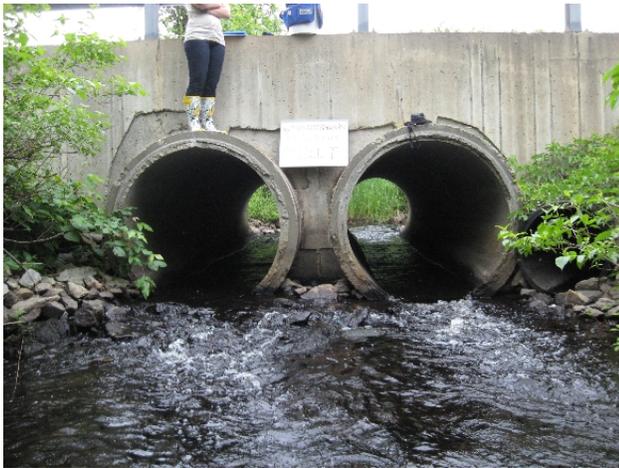
The crossing at Railroad Street is newer construction consisting of 2 concrete pipe culverts embedded in a concrete bridge structure. The river enters the inlet at a sharp angle. The culverts present a mild to severe constriction to the stream flow. There is a stormwater outflow pipe at the outlet. The banks are thick with vegetation.

Figure 4 Peters River inlet at Railroad Street.

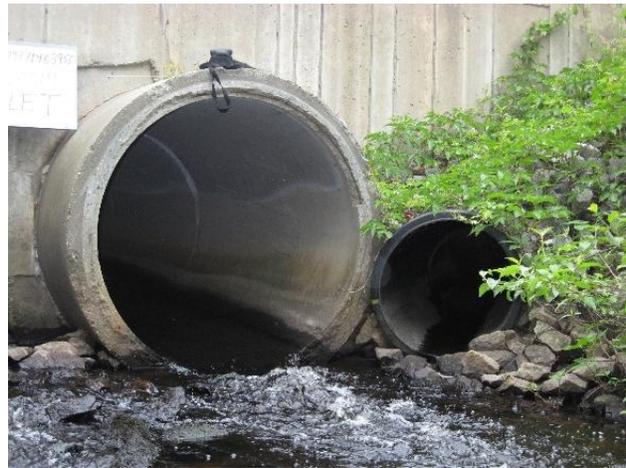
Figure 5 Peters River outlet at Railroad Street.

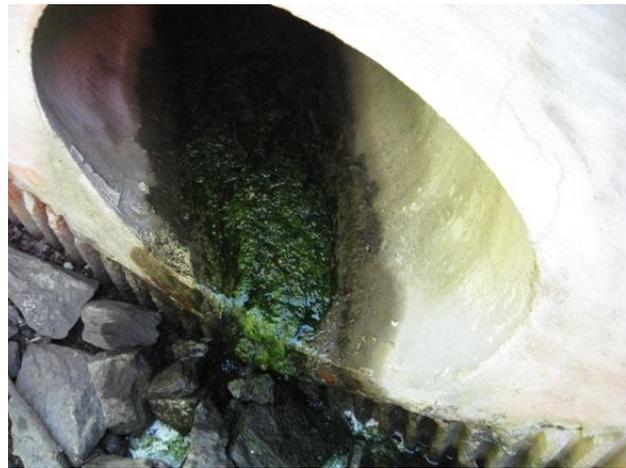
The crossing at Pulaski Boulevard underwent a major reconstruction in 2010. There is a stormwater outflow pipe adjacent to the inlet. It is presumed that this comes from the detention basin adjacent to the Bellingham Lumber property at the corner of Lake St and Pulaski Blvd. Algae were observed in the outflow pipe. Small fish, crayfish, and, surprisingly, an eel were observed. On the outlet side of the crossing, the parking lot of Lake Street Auto, an auto body shop, lies adjacent to the river with a small buffer.

Figure 9 Outflow adjacent to inlet at Pulaski Blvd.

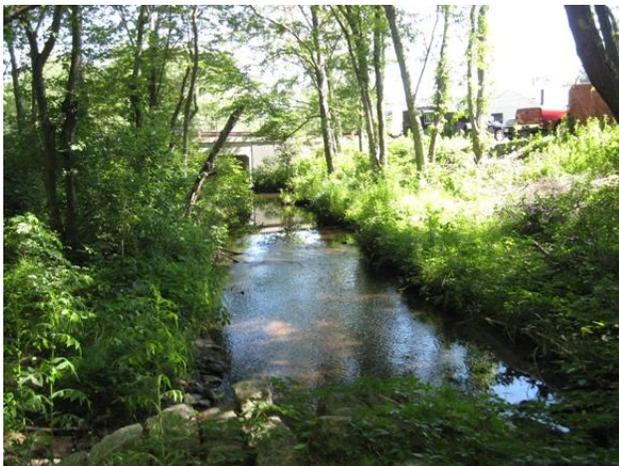
Figure 10 Looking upstream toward Pulaski Blvd. Auto body shop on right.

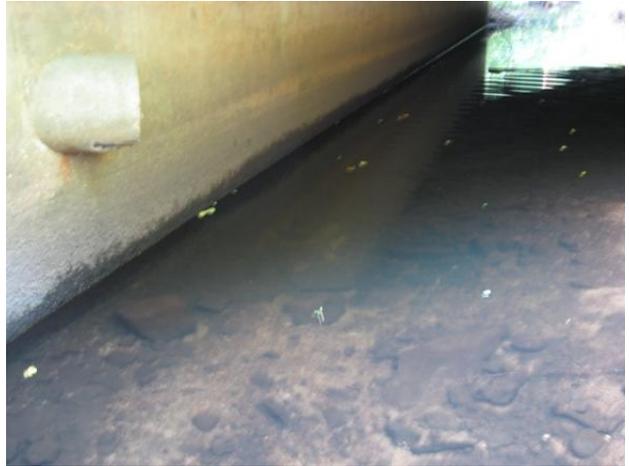
At the Wrentham Road crossing, the usual thorns/wild grape vegetation was observed. Under the bridge, stormwater outflow caused deep scour near the outlet. The river contains man-made “artifacts”. Below the crossing, we see the last of the natural streambank before a section of alteration between Wrentham Road and Paine Street. A concrete retaining wall replaces the bank on the east side. Yards and a paved lot extend to the river. Several outflow pipes, a foot bridge and an aerial pipe crossing are present.

Figure 15 Outflow at Wrentham Road causing scour.

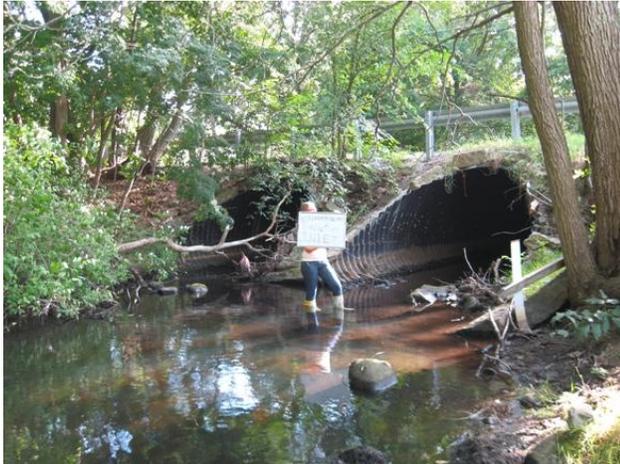
The crossing at Paine Street is showing signs of disrepair and erosion. The culverts appear to present a restriction to the stream. This location is a site in the Blackstone River Coalition Water Quality Monitoring Program. Crayfish were observed.

Figure 18 Peters River inlet at Paine Street.

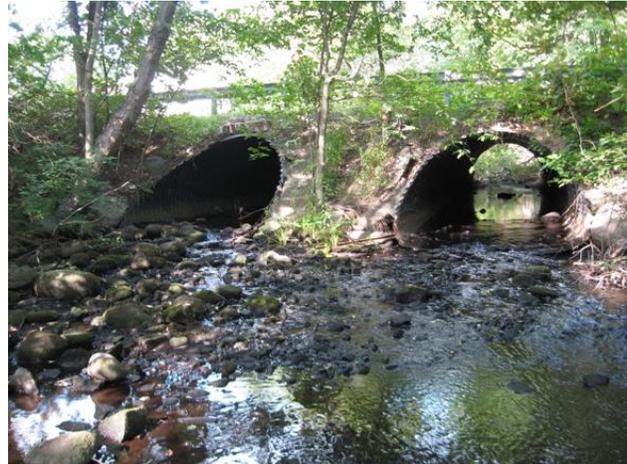
Figure 19 Peters River outlet at Paine Street.

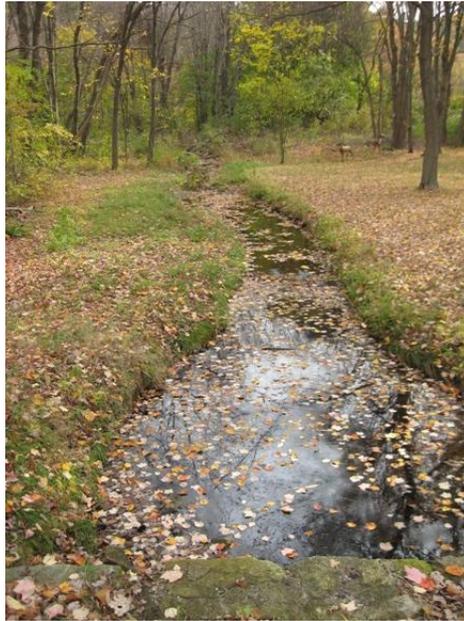
Summer Street (west side) is a dead end with an outflow culvert exiting at the center of the road feeding a stream that leads directly to the river.

Figure 34 Outflow culvert at end of Summer Street.

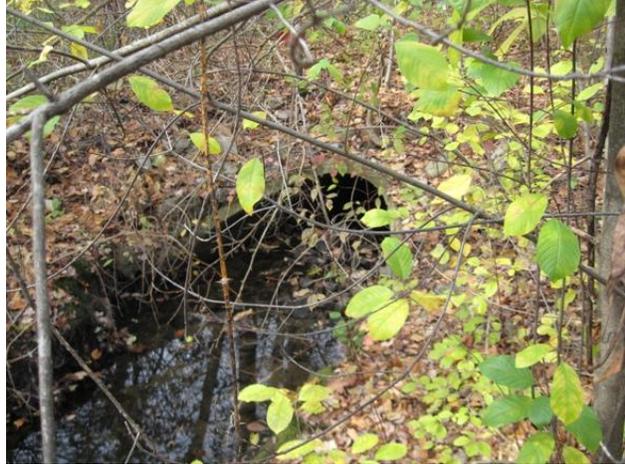
Figure 38 Outflow from Winter St to Peters River.

On Winter St (west side), the stream seen from Gaby Lane is the outflow of a culvert leading from the street. There is approximately 50 feet of wooded buffer between the residential lots and the river. Walking downstream from Winter St., backwaters and properties sloping to the river are observed on the east bank. The west bank is vertical and under cut. Some duckweed and natural sheen was observed and the stream is flowing slowly. The photographs are in sequence moving downstream.

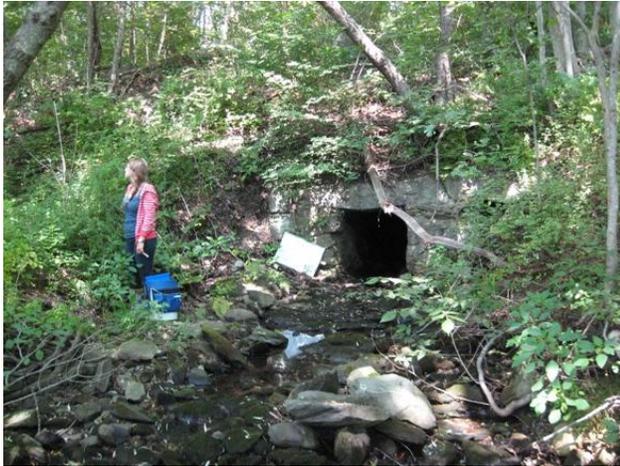
The Arnolds Brook double culvert under the SNETT railbed is constructed of stone and granite block. The crossing was surveyed on July 30 and, as seen in the photo, flow was very low. However, there is strong evidence from the adjacent streambanks that the flow is seasonally varying and the culvert presents a restriction in the spring.

Figure 56 Arnolds Brook inlet at SNETT.

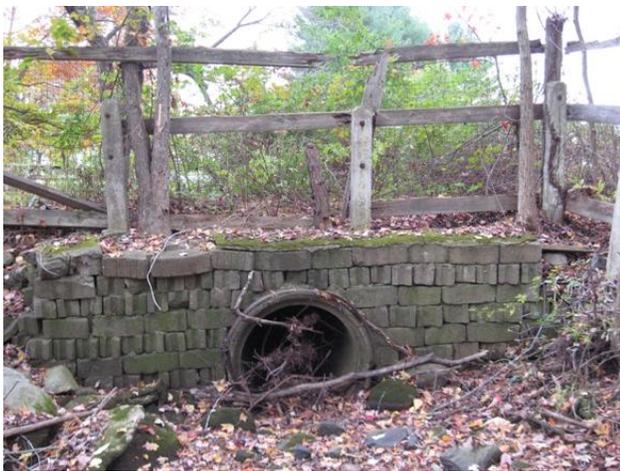
Figure 58 Inlet to underground portion of Arnolds Brook.

Just downstream of the SNETT crossing Arnolds Brook transitions to an underground pipe. Evidence suggests this is a restriction to flow in the spring. The structure surrounding the entry pipe is in disrepair. The underground stream crosses two streets and several residential properties developed in the early to mid 1960's. The stream surfaces in a small wetland in the midst of the development and continues to Lizotte drive.

Further investigation on Arnolds Brook should include a look at the area near the SNETT, stormwater management practices at Pulaski Boulevard and within the residential properties, and a review of activity and future plans at the former Bellingham Drive-in which abuts the stream.

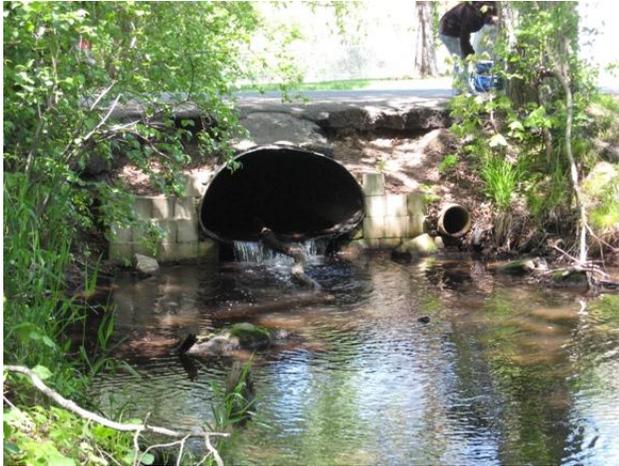
At the Lizotte Drive crossing, the brook enters a culvert about 70 feet from the road. The banks are vegetated with the typical mix of thorns, poison ivy and wild grape. The outlet of the Lizotte Drive crossing shows signs of erosion. An outflow pipe, presumably stormwater, is visible adjacent to the crossing outlet. Another outflow enters from the adjacent property perpendicular to the stream. The stream then travels behind residential parcels to a more commercial area at Pulaski Boulevard.

Figure 60 Arnolds Brook outlet at Lizotte Drive.

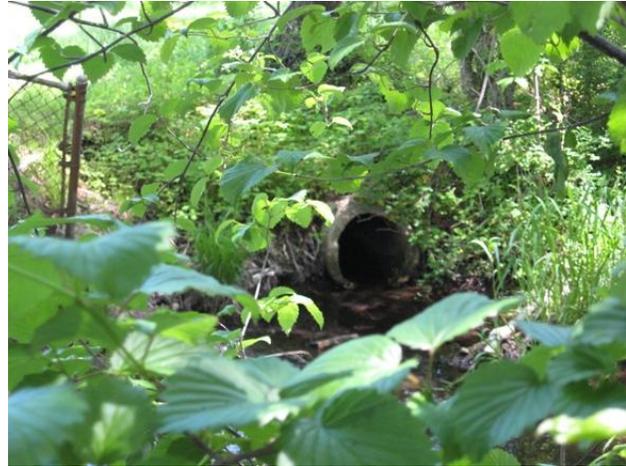
Figure 61 Outflow from adjacent property at Lizotte Drive.

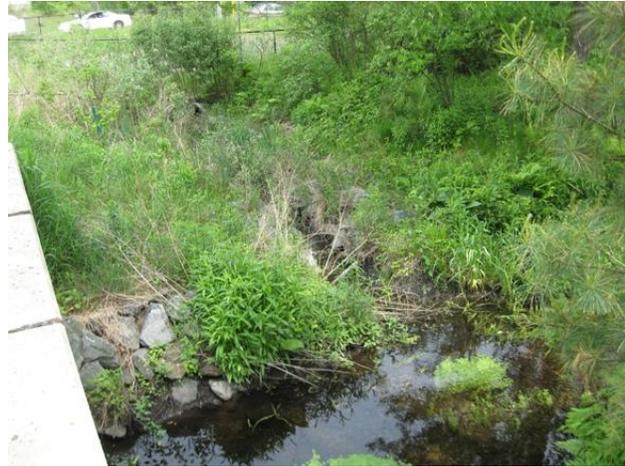
The outlet side of the Pulaski Blvd crossing is different from the inlet. It is more open and less overgrown. There is a detention basin at the the corner of Deer Run Rd and Pulaski Blvd that feeds into the brook. Small fish (< 3”) were observed. Patches of duckweed were observed. One clump of Japanese Knotweed was observed on the bank.

Figure 65 Flow from detention basin adjacent to Arnolds Brook at Pulaski Blvd/Deer Run Road.

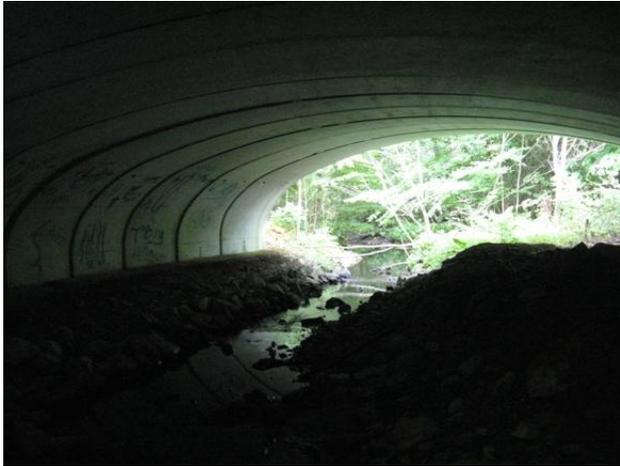
Upstream of Hales Pond, Bungay Brook passes through a 2005 residential development. The stream is surrounded by protected open space owned by the town of Wrentham which contains DEP wetland areas. The crossing at Whipple Brook Road is well designed providing ample passage but was found to be blocked by a stone ford. Macroinvertebrates, frogs and animal tracks were observed.

Figure 69 Bungay Brook - Whipple Brook Road crossing.

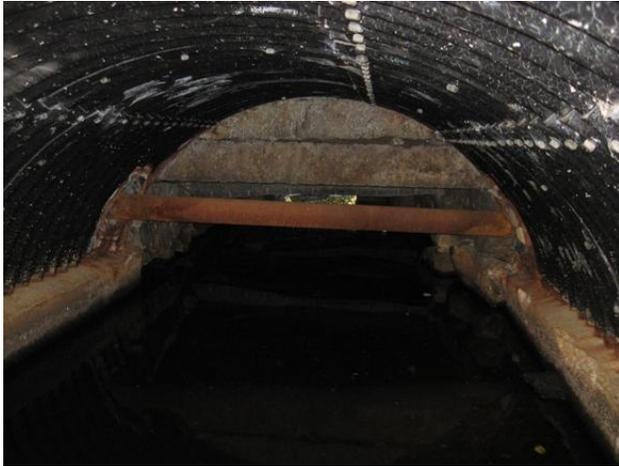
The crossing at Wrentham Road near Squire Lane is in need of attention. The crossing is a mixture of granite block (inlet) and corrugated steel/concrete (outlet) indicating that the road was either widened or a wash-out was repaired. The road is sinking toward the inlet side allowing stormwater to enter the stream directly from the road surface. The inlet culvert appears to restrict stream flow. The septic system for the residence at the corner of Squire Lane and Wrentham Road is being replaced (failed cesspool) at the time of the writing of this report. The old system was likely in the Title V buffer zone. The status of the systems on the neighboring 2 properties is unknown but they may also fall in the buffer zone.

Figure 74 Bungay Brook outlet near Squire Lane showing varying construction.

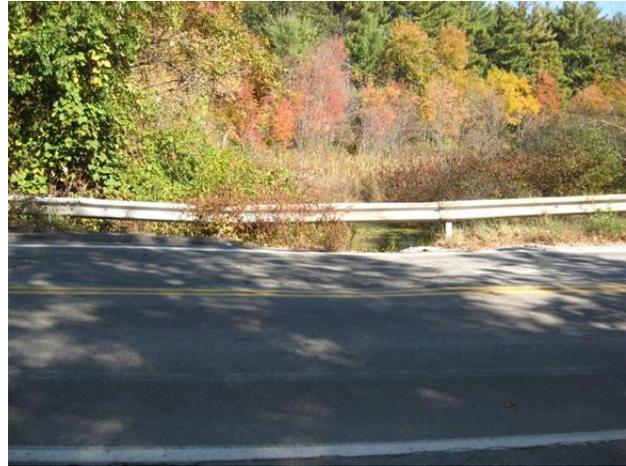
Figure 75 Wrentham Road slumping toward Bungay Brook inlet.
