Shoreline Survey Report and Action Plan Mumford River - May 2006 Blackstone River Watershed Association

Mumford River Stream Team Report

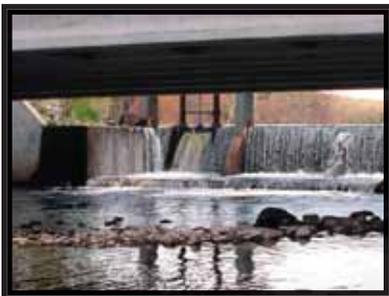
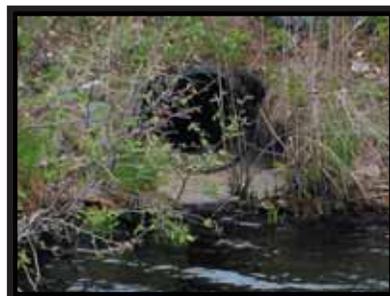
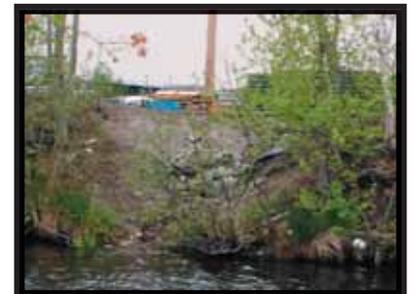
Along the waters edge at a residential site there are several piles of grass clippings to keep vegetation from regrowth. Water is full of what appears to be algae (Figure 7 and Figure 8).

Section 6. Surveyors Bob and Joanne Germain assess dam structure, drain pipes, erosion and trash along the Mumford River

- **Neighbor is dumping grass clippings into the water and needs to be informed about dumping**
- **Trash removal along river**
- **Lily pads and other plants are taking over waterway**

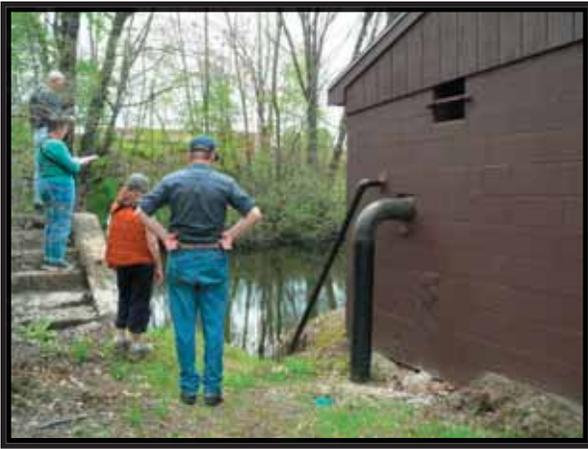
Surveyors assess pump house at Whitinsville Golf Course, Linwood, MA.

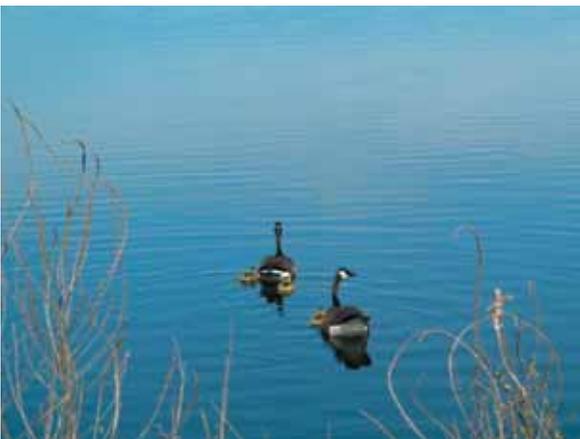
Geese on the Mumord River, Linwood, MA

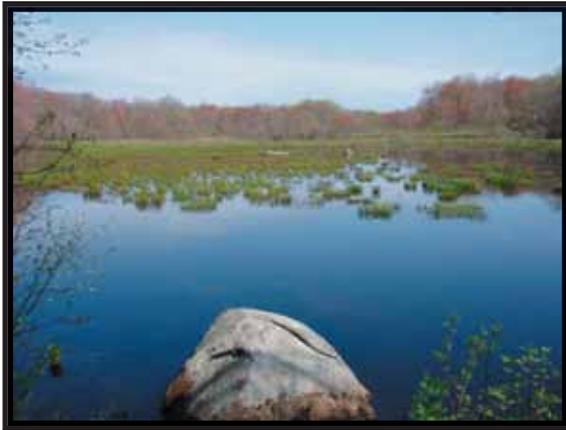
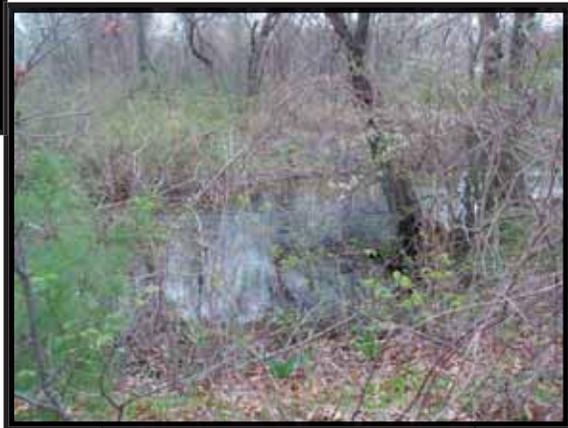
Section 9 - Images along Hartford Street/Route 16 - Capron Park Mill Dam
Surveyor: Maggie and Jim Plasse

Started survey at Capon Park Mill pond and dam at strip mall on Route 16 in Uxbridge (N 42.07722, W 71.62867). Informal canoe launch on walking path behind parking area (N 42.07742, W 71.62888). Walked path on west bank of river. Wooded and wetlands between railroad bed provide protection to the river in this section. East bank of river appeared to be protected by natural vegetation also. Some trash found along pathway. Appears to be teen party destination. River vegetation includes arrowheads and feathered plants. Abandoned oil tank found. No oil in it. Been there a while. Dry well from storm drain. No pipe visible. Open area with kid's toy car. Trail turns to marshy wetlands. Had to continue walk on rail bed (N 42.08196 W 71.60100). Followed Homewood Street back to river from rail bed. River protected by wetlands and wooded areas up to mill on Hartford Street. Not passable on foot up stream between Homewood street. At Hartford St. a resident said that river is navigable between Hartford St. and Route 16. Would have been better to survey this section by boat. (N 42.08500, W 71.60176).
